SERIAL NO. **SSC-78**

FINAL REPORT
(Project SR-124)

**PART II: INVESTIGATION OF THE PERFORMANCE
OF WELDMENTS AND PRIME PLATE OF
ABS-B STEEL**

W. S. PELLINI and E. W. ESCHBACHER
Naval Research Laboratory

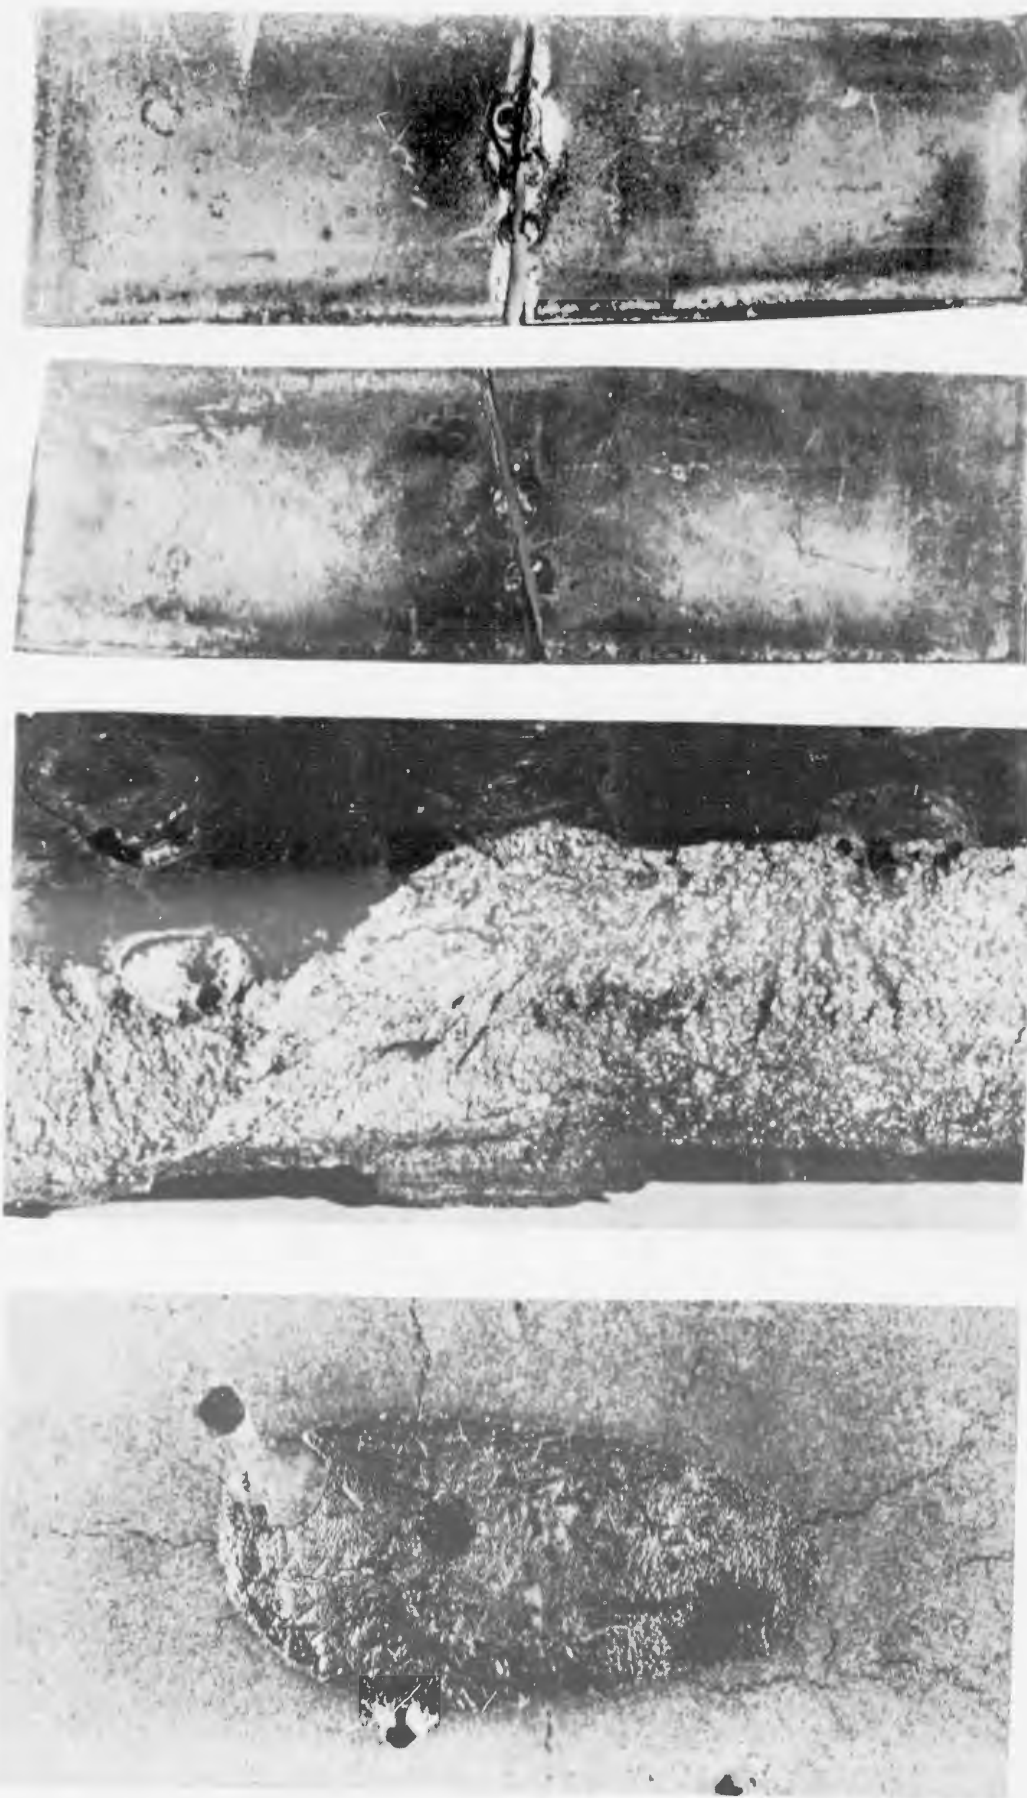
Fig. 8. Top - "A" and "B" Drop Weight Test Pieces with Arc Strike Defects (See Fig. 7)
Center - Arc Strike Origin of Fracture in 20" x 20" Weldment.
Bottom - Cracks Associated with Arc Strikes; the Crater is Approximately 1/8" x 1/4" actual size.

Following these tests, the effect of the presence of arc strikes was investigated. Material was removed from the sides of a bulge test sample (as denoted by the dotted area A and B shown in Figure 7), and arc strikes were applied using a carbon-arc technique. This method produces reproducible crack conditions adjacent to the arc strike crater. The use of conventional E6010 electrodes to produce arc strikes may also result in cracks but not reproducibly, i.e., the arc strikes which result may or may not be associated with sharp cracks. The next step was to determine the critical temperature below which deformation is not possible in the presence of the sharp cracks associated with arc strikes. This temperature may be determined from the Charpy V transition curve (below 10 ft-lb) or more expeditiously by means of the drop-weight technique. Based on the previously described drop-weight tests of ABS-B steel, it was suspected that the critical temperature was approximately 20°F; accordingly, sections A and B were drop-weight tested at 20°F. The resulting fractures indicated that this temperature was appropriate for the comparisons intended. Figure 8 (bottom) illustrates the type of cracks which are obtained with arc strikes and the fractured drop-weight specimens A and B (top).

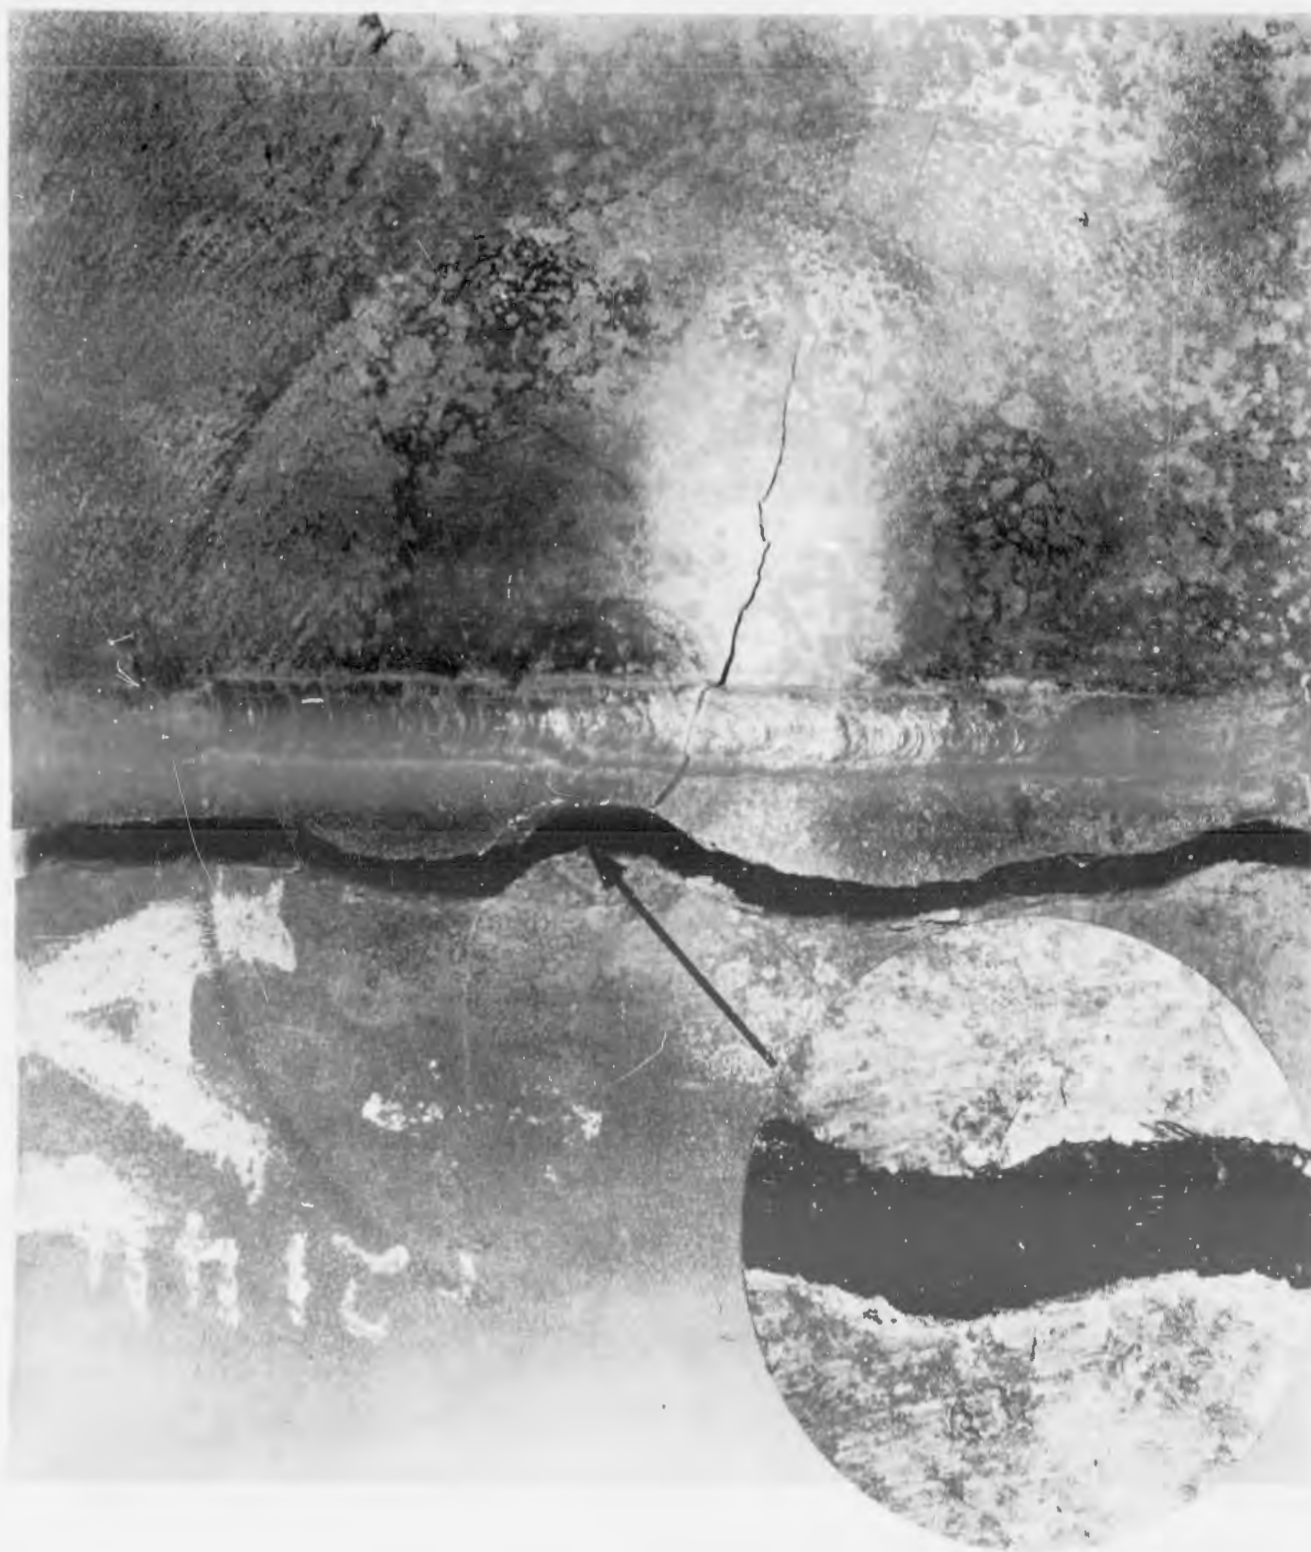
Fig. 11. Failure of P34, G180 Weldment Resulting from the Presence of an Accidental Arc Strike. The Insert Shows Small Cracks in the Arc Strike Region.

The one shot (1% T.R.) failure of P34, G180, at 40°F is explained by the nature of the failure shown in Figure 11, which shows no relation to the weld. The presence of an accidental arc-strike at the source of failure was responsible for this anomalous behavior. Several sharp, small cracks may be observed radiating from the arc strike which caused the initiation of failure. The arc strike was present in the weldment as received from Philadelphia Naval Shipyard and was not noticed prior to testing, despite critical X-ray and visual examination of all weldments on receipt at this Laboratory. This is another excellent example of the critical nature of minute, accidental imperfections when present on steel which is susceptible to brittle fracture at service temperatures. Unless the notch toughness of the ship steels are improved to an extent sufficient to develop insensitivity to the presence of such accidental defects, the benefits expected from high quality welds will not always be realized in service. This fact is illustrated by the excellent performance of G180

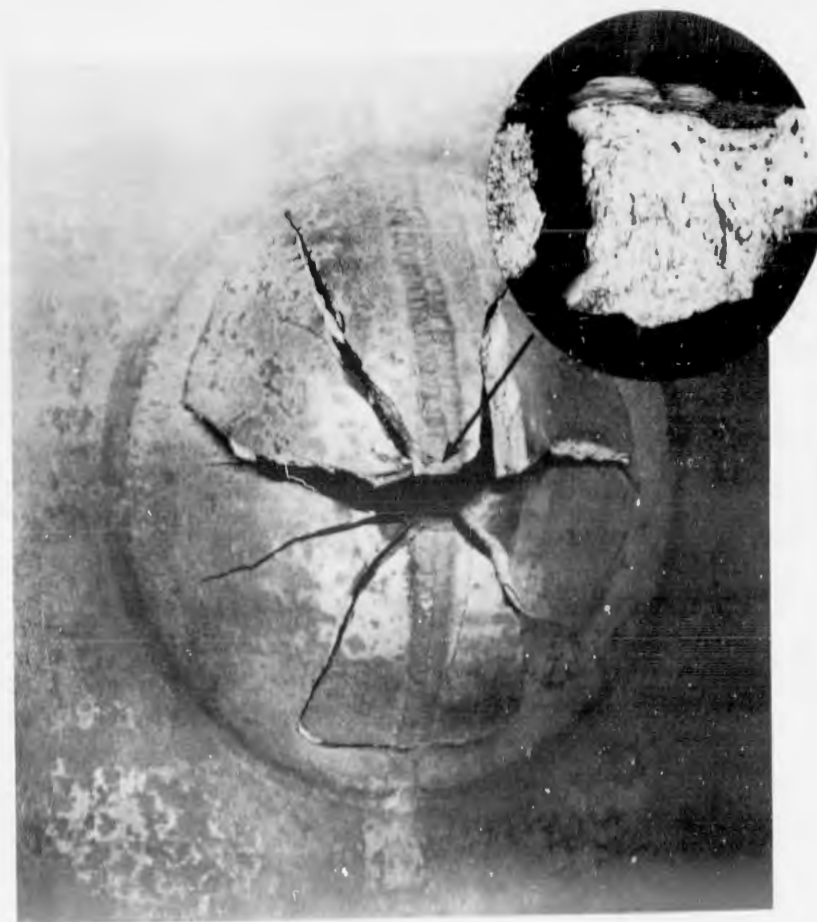
Fig. 12. Typical Fractures of E6010 Weldments (Top) and G180 Weldments (Bottom).

The typical fracture characteristics of G180 and E6010 weldments are illustrated in Figures 12. The chevron markings indicated that the initiation of fracture occurred in the weld proper for the case of the E6010 weldments. In the case of the G180 the site of fracture initiation could not be established with certainty. In general the location indicated by the chevron markings was at fusion line area but without clear distinction as to weld or H.A.Z. side of this general area.
